ERDC/CRREL TR-03-17

Design and Operational Issues While Tunneling in Firn at the South Pole Station

Michael Walsh

September 2003

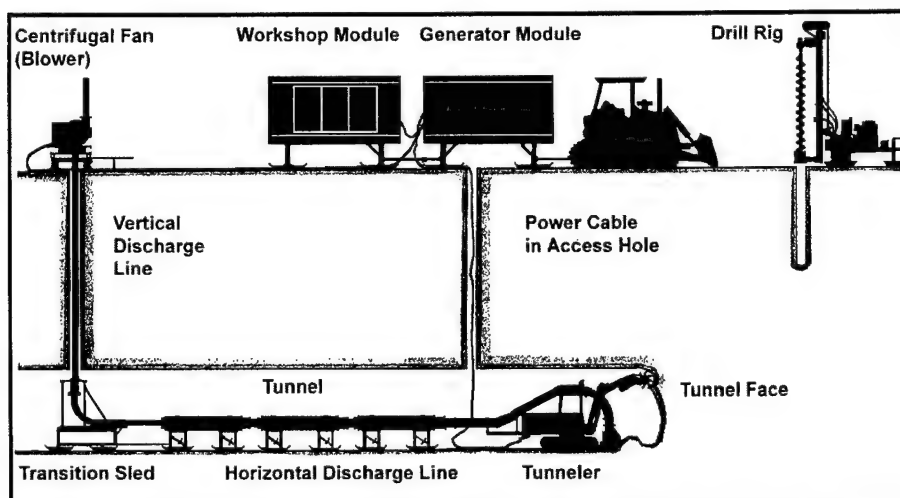
The South Pole Tunneling System is designed to be self-supporting. The basic layout is given in Figure 2. The tunneler is based on a small diesel-hydraulic tracked excavator, modified to run on electric power when underground. The debris disposal system is powered by a surface-based centrifugal fan. Power for all components is provided by a diesel-powered generator set in the generator module. A workshop is provided for minor repairs, and a small warm-up shelter (not shown) is provided for below-surface relief from the cold. A ski-mounted drill rig is used to drill holes for power and discharge line access during tunneling operations and to form the escape risers following completion of tunneling.

Figure 2. South Pole tunneling system (drawn by Thomas Vaughan).

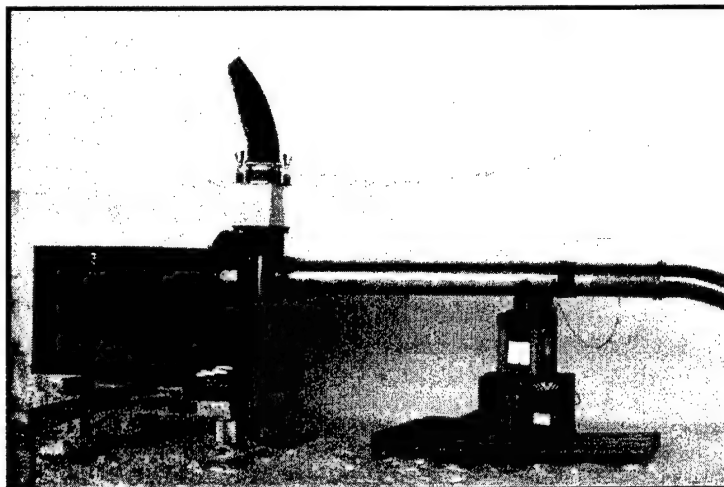
Figure 7. Expandable straight mixing tube at centrifugal fan inlet (photo, M.R. Walsh).
